**ALABAMA HAZARDOUS WASTES MANAGEMENT AND MINIMIZATION ACT  
(AHWMMA)  
Compliance Evaluation Inspection (CEI) Report**

Hanil E Hwa Interior Systems Alabama, LLC  
200 Craig Industrial Drive  
Selma, Dallas County, Alabama 36702

February 25, 2016

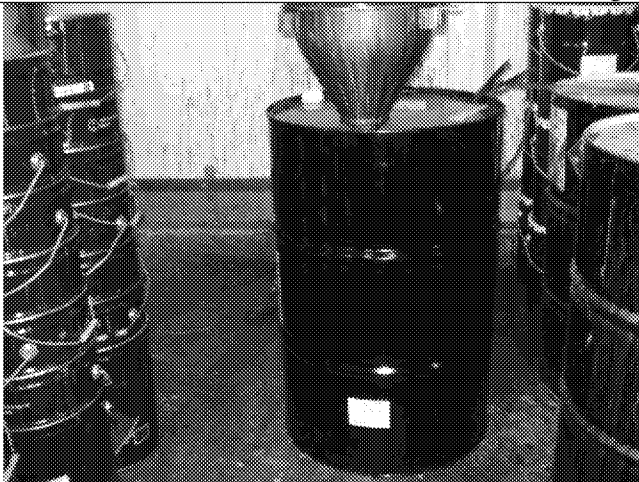
The upper trim of each door panel must be painted to match the specified color code. Solvent and paint wastes are generated when the paint guns are purged between color batches. One 55-gallon close-top satellite accumulation container was staged in the product area to receive the purged solvent. This drum was equipped with a latching funnel screwed into the bung. The drum was closed, but it was not marked or labeled in any way. See Photograph #2.

2. Paint Shop – unmarked SAA container

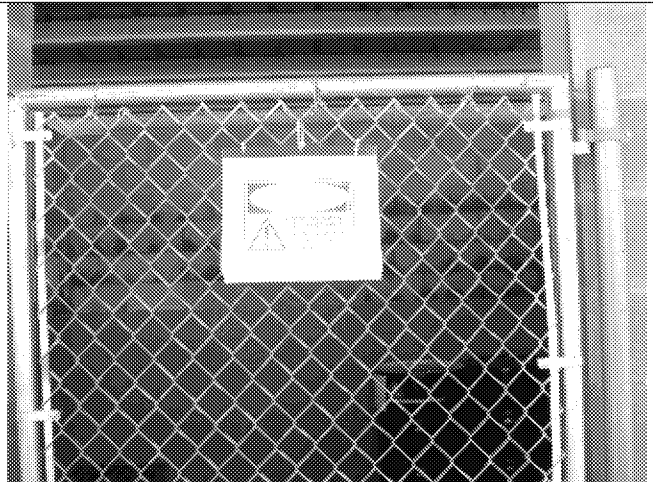
This is a small concrete block building at the northwest end of the access road that runs along the rear of the main facility. The entrance is closed by a locked personnel gate. A paper sign with the legend "Danger – Hazardous Waste Storage Area – Unauthorized Persons Keep Out" was affixed to the gate. Inside, there were two 55-gallon close-top drums, which Mr. Rossi said held paint waste. The drums were closed and appeared to be in good condition, but were not labeled with the words "Hazardous Waste", the EPA hazardous waste numbers, or an accumulation start date. The floor of the building

appeared to be uncoated concrete. See Photographs #3 and #4.

3. 90-day accumulation area

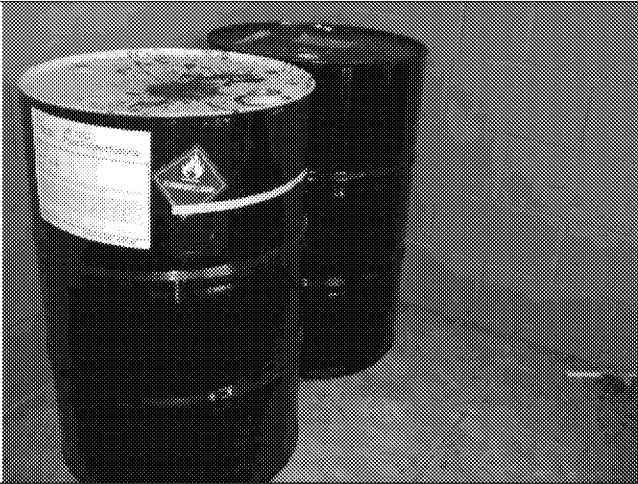
4. HW Storage – unlabeled, undated drums

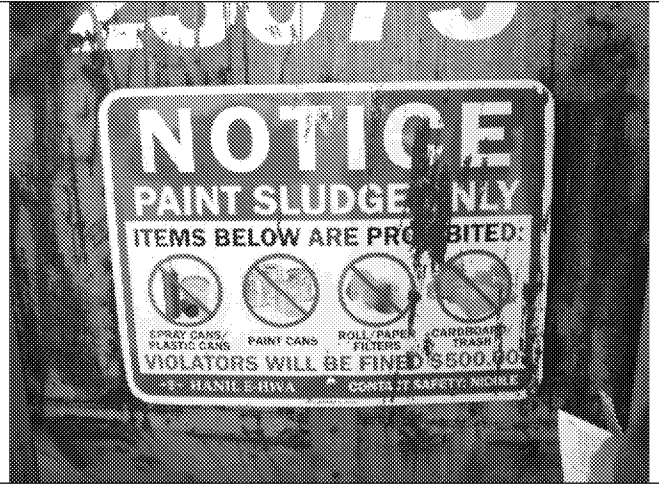
Immediately south of the HWSA we saw a roll off container of paint sludge. Per Mr. Rossi, the paint sludge is nonhazardous waste; a sign on the roll off warned employees not to place any other material in the container. See Photographs #5 and #6.

5. Sign on paint sludge roll off

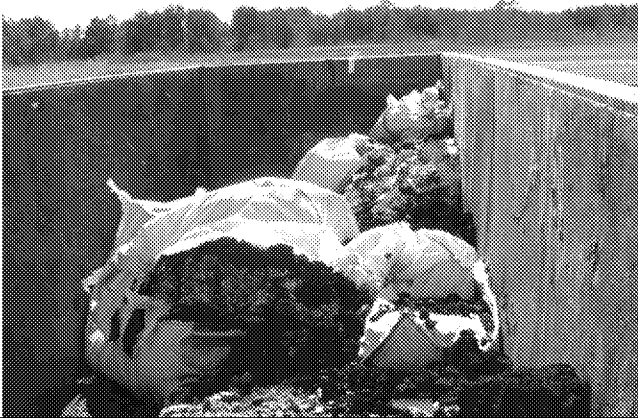
6. Contents of paint sludge roll off

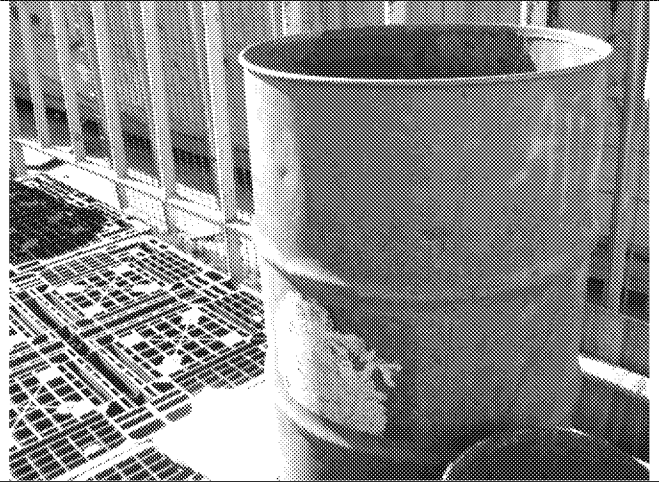
On a spill pallet beside the roll off was an open-top 55-gallon drum that held twelve discarded intact aerosol cans of "Per-Fix Flaw Repair Coating 7205AA". Upon testing, some of the cans still held dispensable product. According to the Safety Data Sheet, the product includes three components that are U-listed hazardous wastes when discarded: ethyl acetate (EPA hazardous waste number U112); xylene (U239); and toluene (U220). The drum was open, unmarked, and very rusty. There were dozens of aerosol can caps on the ground beside the spill pallet and in the spill pallet itself. Neither facility representative could tell us how the aerosol cans and their contents are managed. See Photographs #7 through #9.

7. Open, unmarked drum containing spent aerosols

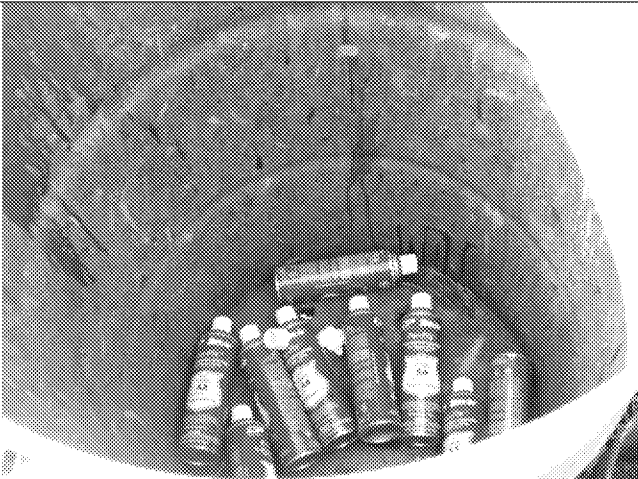
8. Drum containing spent aerosols

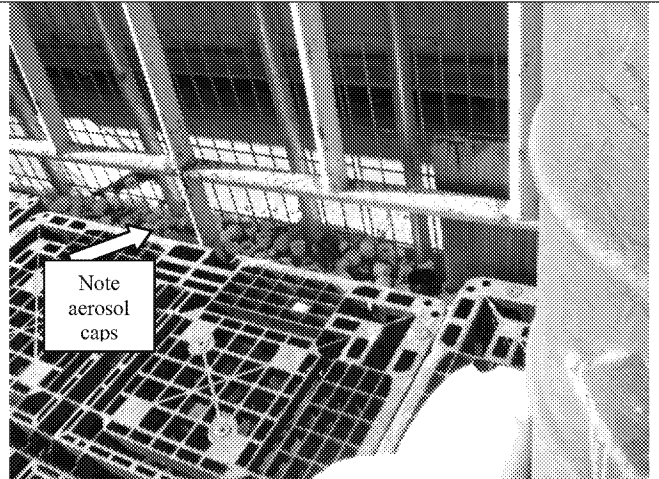
9. Discarded caps from aerosol cans

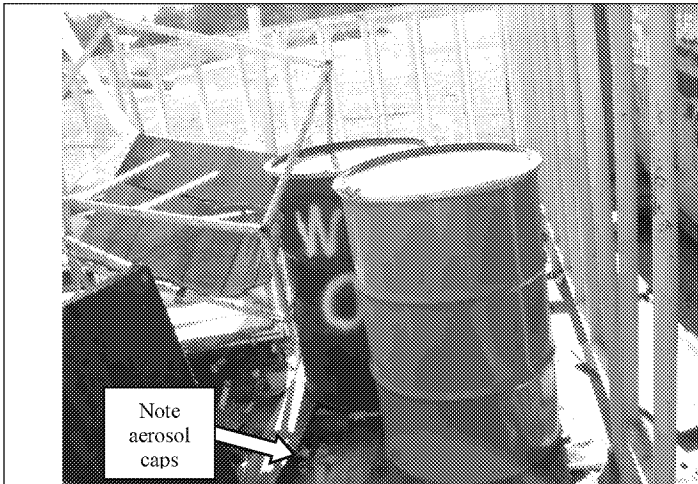
Behind the drum holding the aerosol cans, there were two more open-top 55-gallon drums; these were closed and facility representatives were unsure of their contents. Upon opening, both appeared to hold used oil; one also held seventeen additional aerosol caps.

The first drum was not marked in any way; on the second, the spray painted letters "WA" and "O" were visible, but the area was too crowded to ascertain the rest of the markings. The drum lids were secured with clamping rings. See Photographs #10 and #11.

10. Unmarked or improperly marked UO drums

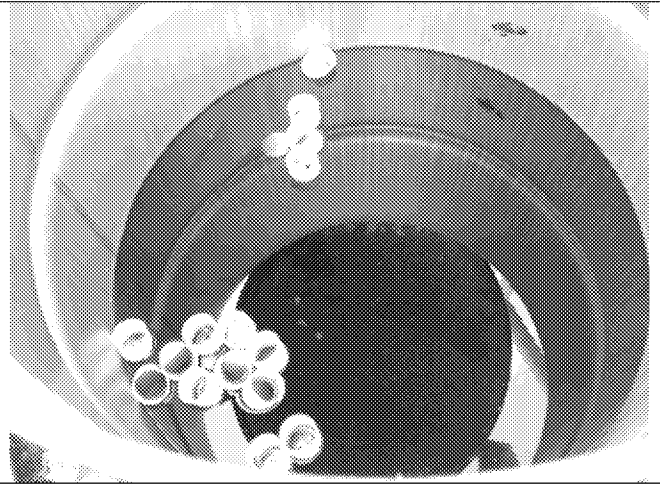
11. Used oil and discarded caps from aerosols

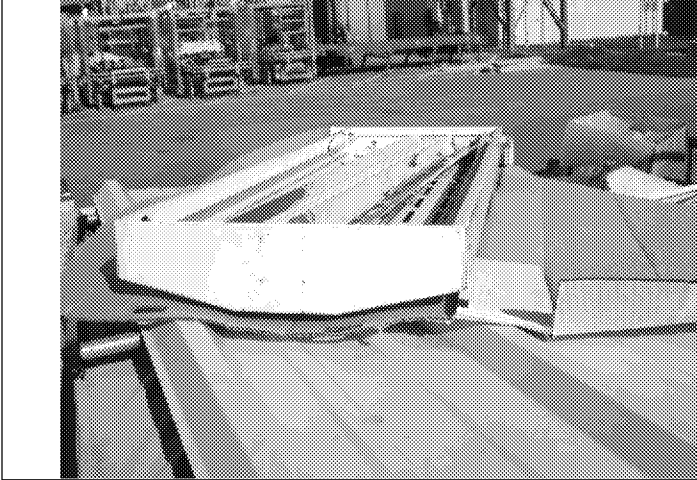
One fluorescent light fixture and five HID light fixtures had been discarded in this area. All were stored with no protection from the weather; each of the HID fixtures was bent. The facility representatives were not sure if the fluorescent fixture was useable, but stated the HID fixtures could not be used because the metal bodies were bent. See Photograph #12.

12. Discarded fluorescent fixture

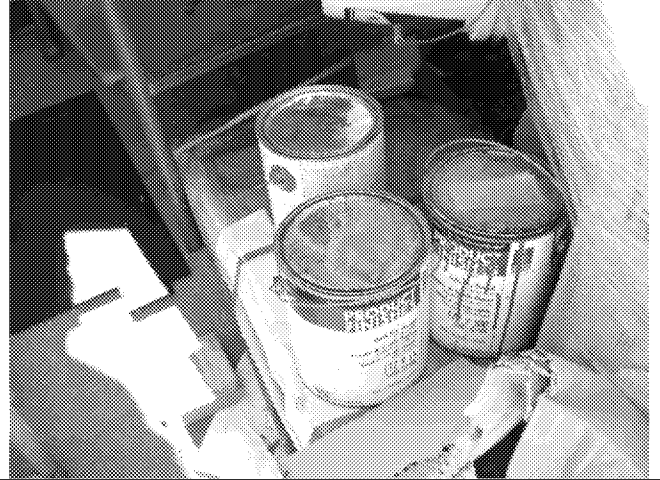
A few feet to the south, we saw three 1-gallon cans of "Quick Dry Enamel" paint that were stored out of doors with no protection from the weather or temperature extremes; two of the cans had rusted lids. At least one can seemed to be solidified. The facility representatives were not sure if the other two cans were usable product or waste. See Photograph #13.

13. Discarded paint

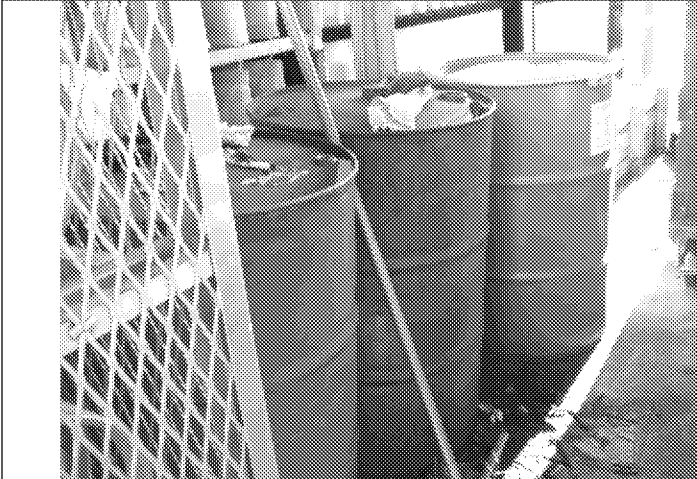
There were five additional 55-gallon drums staged near the paint cans; three were open-top drums, while two were close-top. All were closed, but there was some oily staining visible at the base of the two close-top drums. Upon investigation, all were found to contain used oil. None were marked with the words "Used Oil". The drums all appeared to be sound, but the lid of one close-top drum appeared to be somewhat rusted. See Photographs #14 and #15.

14. Three unmarked used oil drums; note staining at base

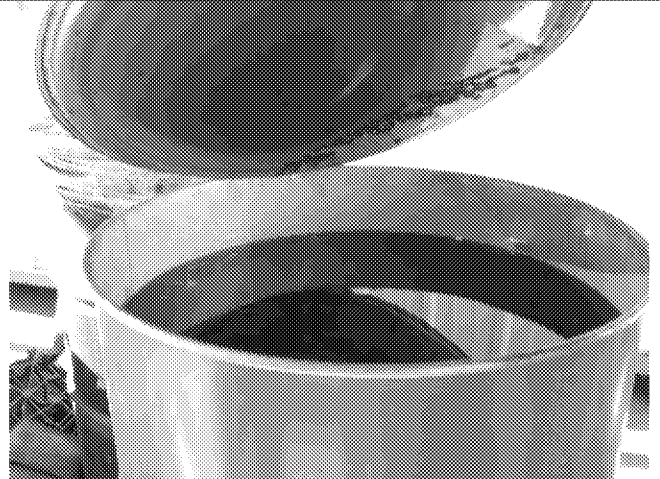
15. Unmarked drum holding used oil

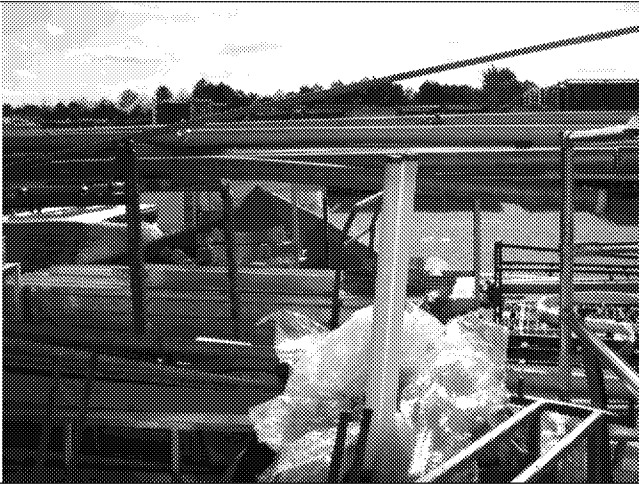
In this same area, we observed two fluorescent lamps that had been placed in a trash can along with discarded plastic film. Again, the facility representatives were not sure if these lamps were usable or discarded. See Photograph #16.

16. Fluorescent lamps

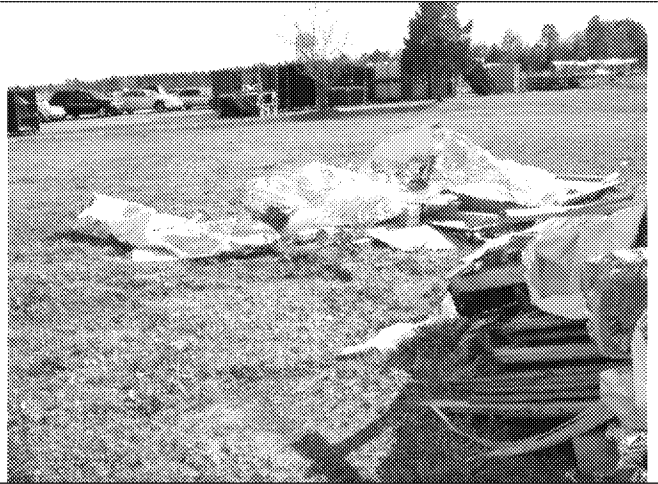
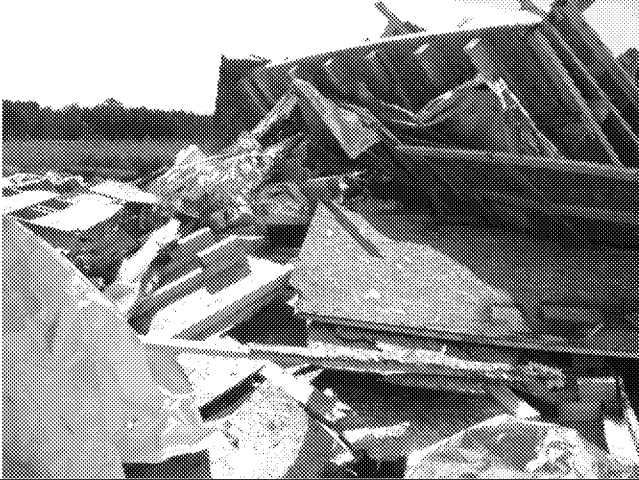
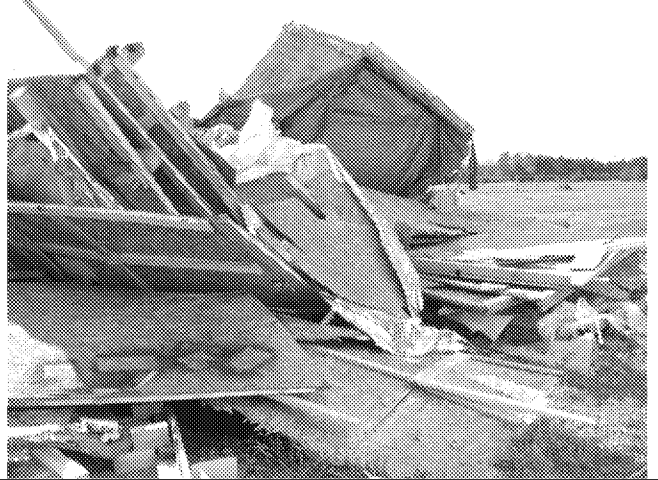
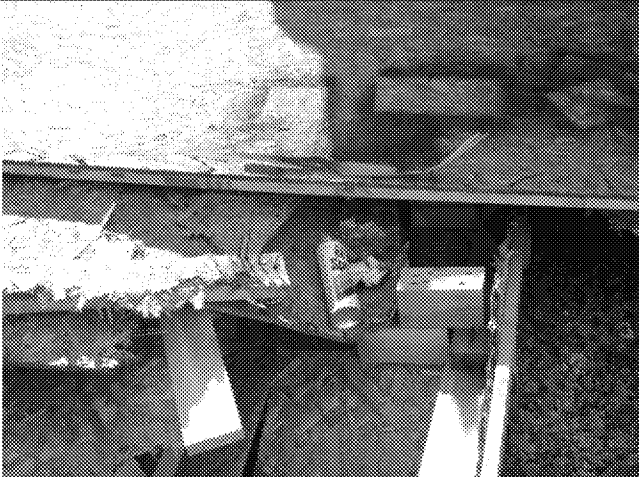
In the field behind the Laydown Area, there was a large pile of discarded construction materials, including weathered and broken sheets of oriented strand board plywood (chip-board), two by four lumber, and sheets of foil vapor barrier. We also saw one discarded aerosol can of lacquer paint among

the debris. The facility representative were not able to say when the material had been deposited or when it would be removed. See Photographs #17 through #20.

17. Construction material dump

18. Construction material dump

19. Construction dump

20. Construction dump – note discarded aerosol can

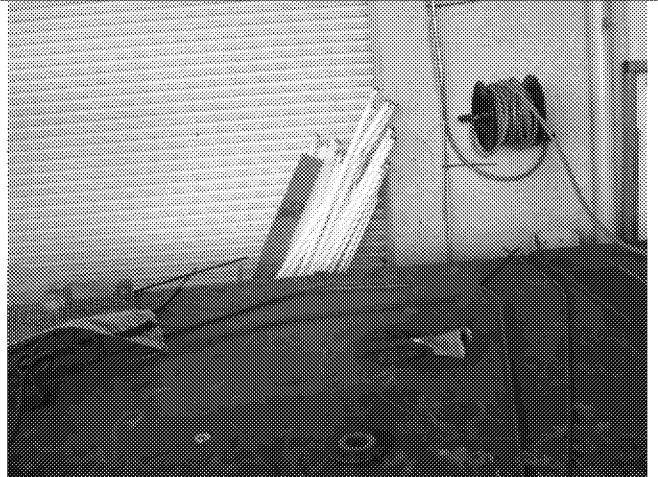
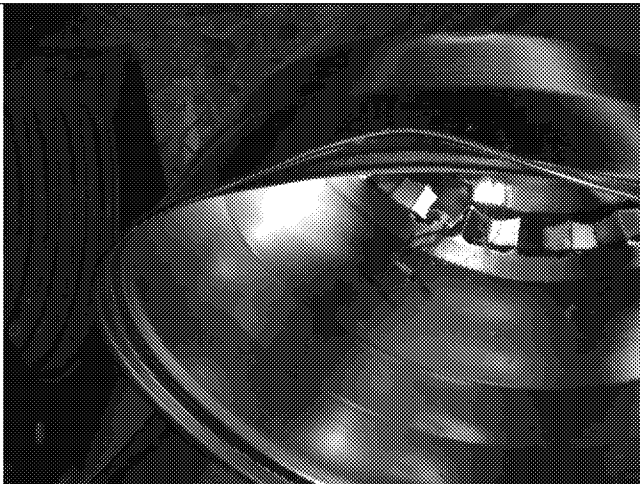
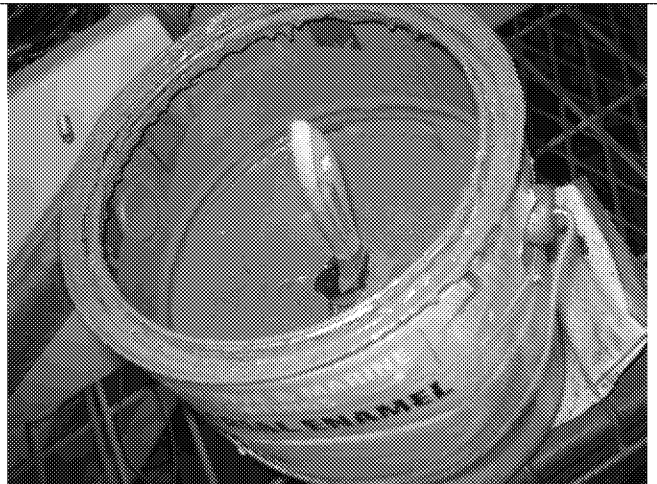
This area is used for repairing and painting parts stands and other equipment used throughout the facility. In the area immediately outside the Maintenance Shop, between the welding table and the wall, there were at least two dozen fluorescent lamps in a plastic trash container. Mr. Robitaille said they had been kept there since at least December and that he thought some of them were still useable. Inside the Shop, we found one damaged HID light fixture with the remnants of a broken lamp and an open 1-gallon can of enamel paint; the can was about half full and the contents had solidified. See Photographs #21 through #23.

21. Fluorescent lamps “stored” outside maintenance shop

22. HID lamp broken in fixture

23. Solidified enamel paint

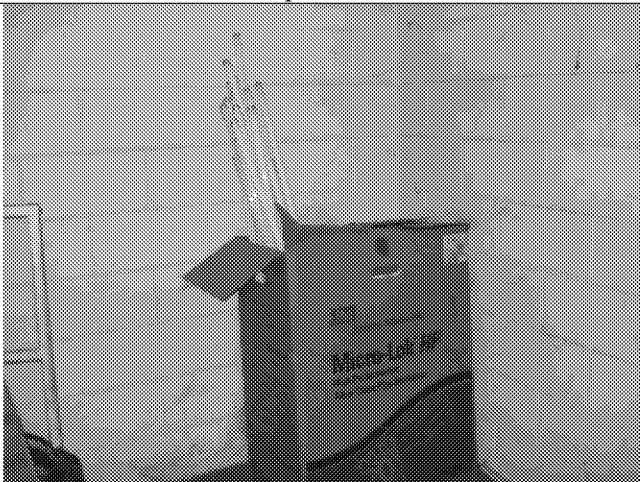
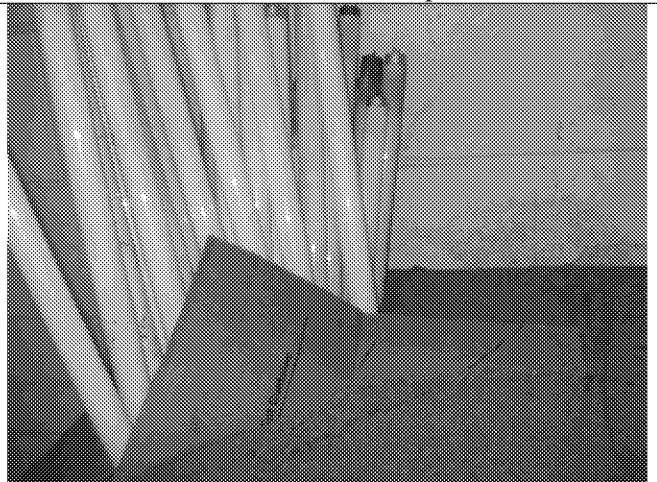
Spent fluorescent lamps and other lighting wastes are stored in the Electrical Room, which is adjacent to the Maintenance Shop. At least fifteen spent fluorescent lamps were protruding from the top of a corrugated cardboard box of filters. The box was not closed, dated, or marked with the words "Universal Waste" or "Hazardous Waste". We also saw three HID light fixtures in this area; these appeared to be intact and two still held intact lamps. Mr. Rossi and Mr. Robitaille were not sure if they were still useable or if they had been discarded. See Photographs #24 and #25.

- In the electrical room, at least fifteen spent fluorescent lamps were protruding from the top of a corrugated cardboard box of filters. The box was not closed, dated, or marked with the words "Universal Waste" or "Hazardous Waste".

24. Spent fluorescent lamps stored in box containing filters

25. Close up of spent lamps
